UNDERWATER BRIDGE INSPECTION REPORT

STRUCTURE NO. 69539

ST. LOUIS RIVER

MINNESOTA DEPARTMENT OF TRANSPORTATION
UNDERWATER BRIDGE INSPECTION

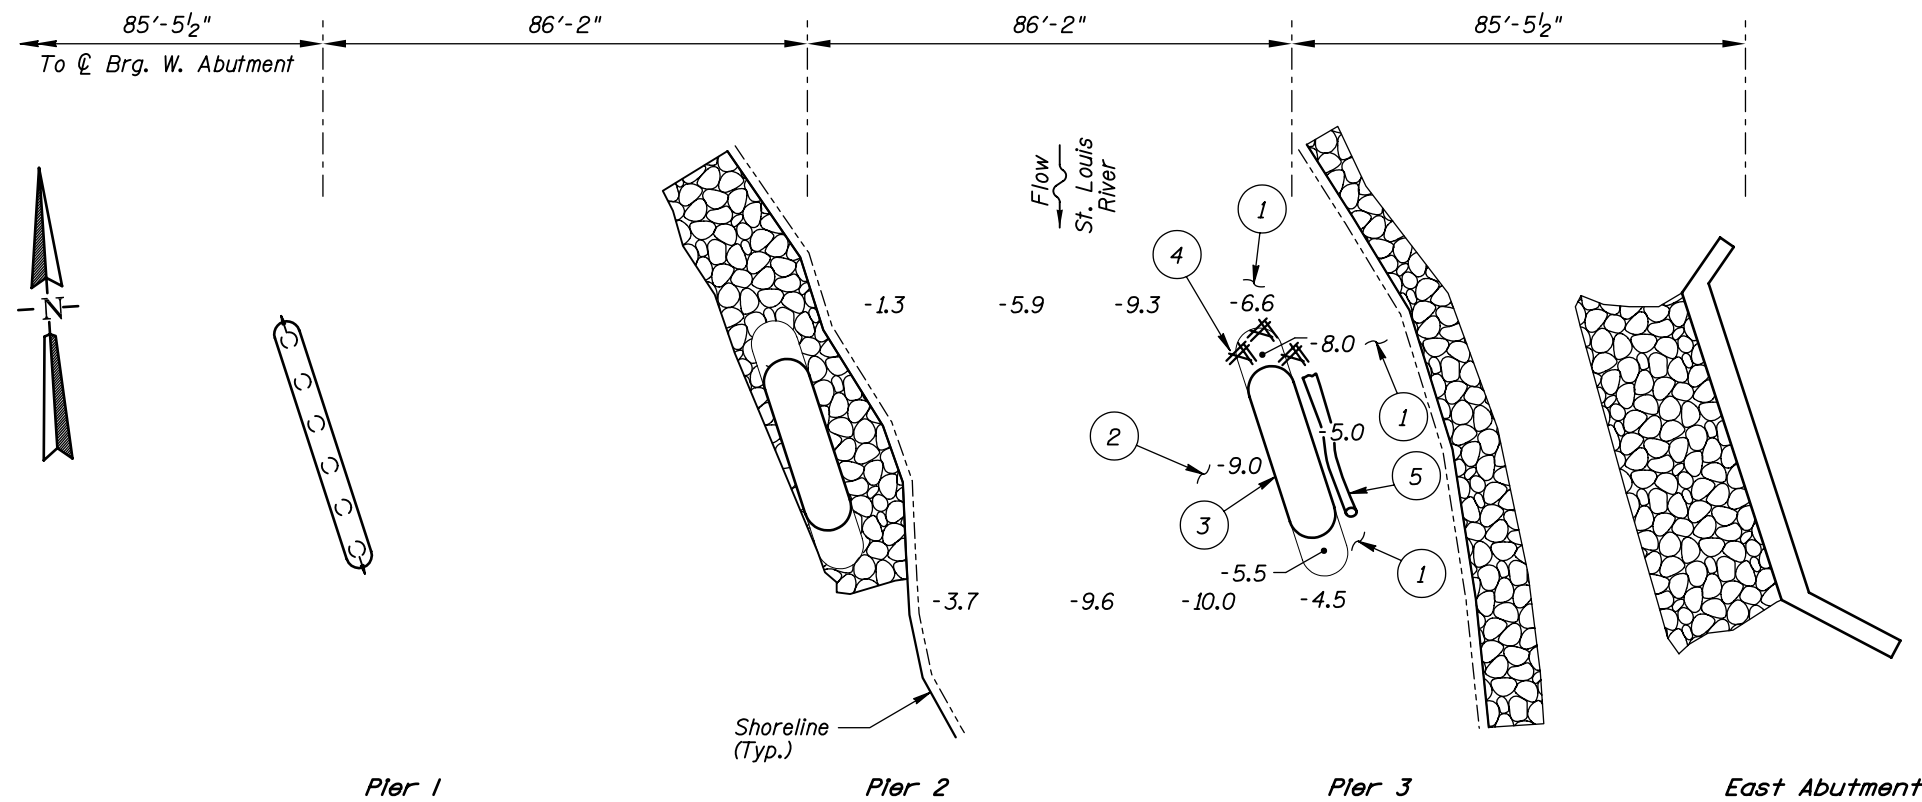
INSPECTION AND SOUNDING PLAN

- 1 The channel bottom consisted of 1-foot-diameter riprap with no probe rod penetration.
- 2 The channel bottom consisted of sandy gravel and cobbles with 6 to 12 inches of probe rod penetration.
- 3 Light scaling was observed from the waterline to 3 feet above the waterline with typical penetrations of 1/8 inch and up to 1/4 inch maximum penetrations.
- 4 A light accumulation of 1-foot-diameter-and-smaller timber debris was observed at the upstream nose of Pier 3.
- 5 An 8-inch-diameter log was observed along the east face of Pier 3.

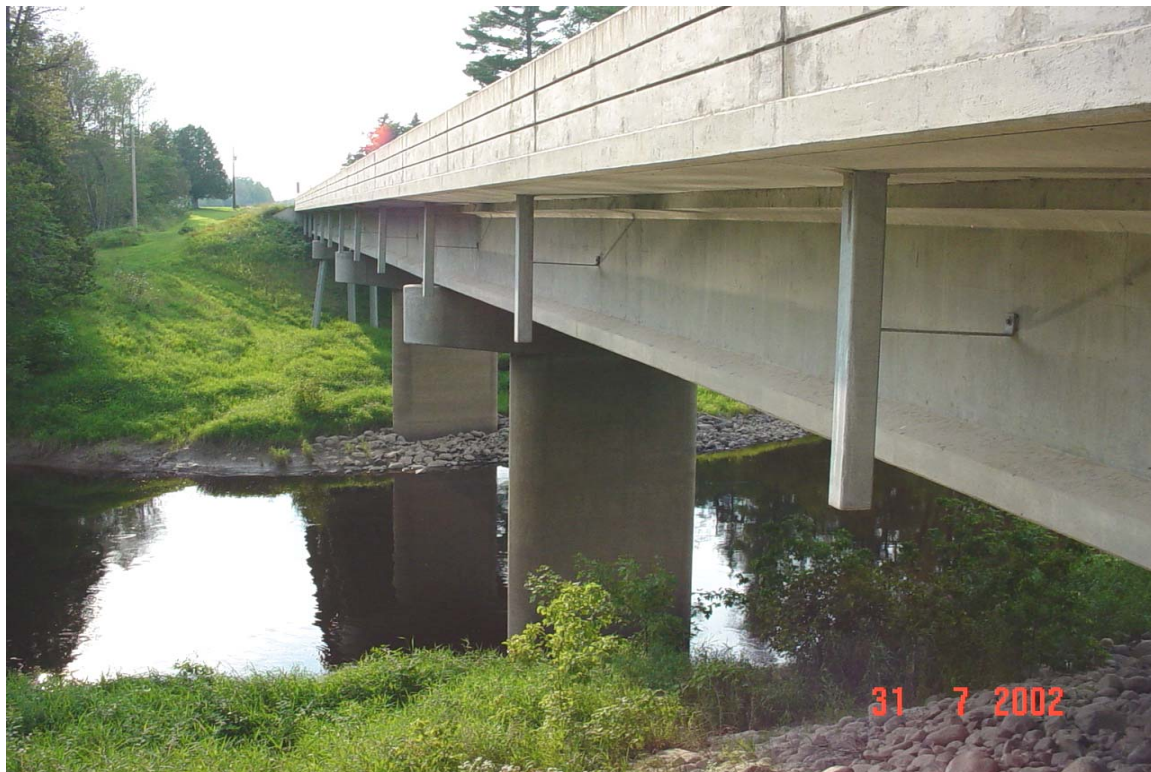
Photograph 1. View of Structure, Looking Northwest.

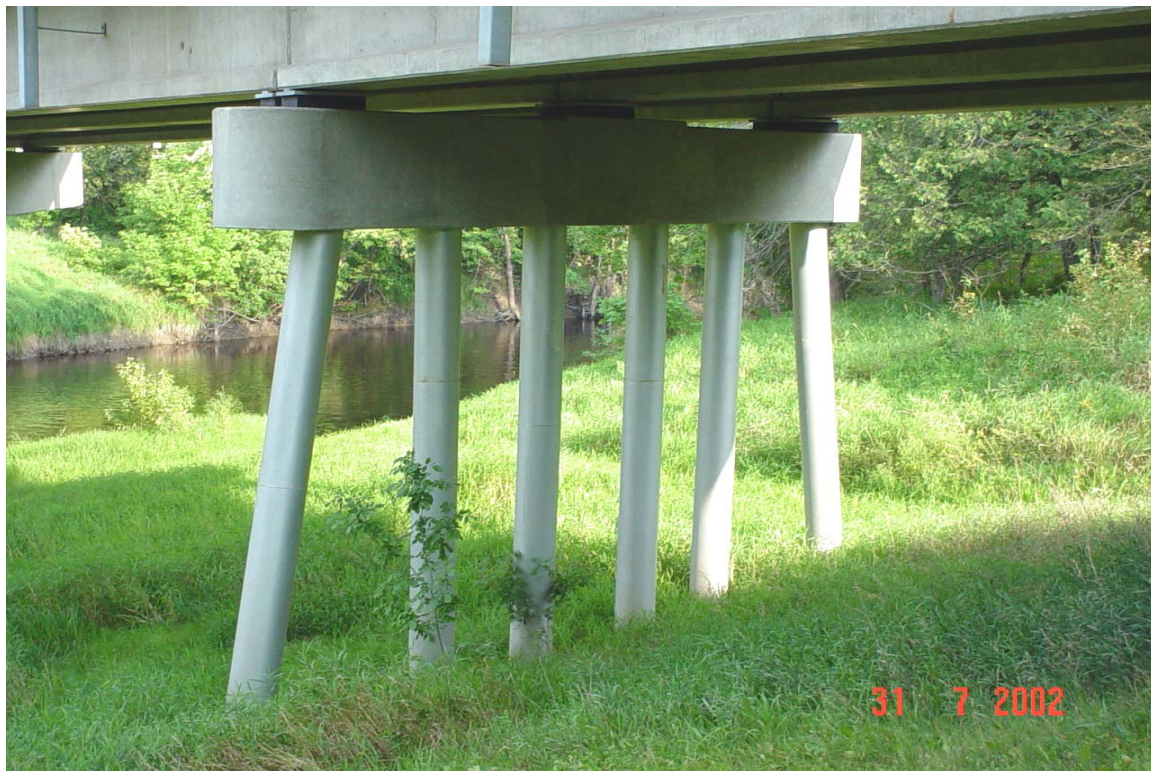
Photograph 2. View of Pier 1, Looking Southeast.

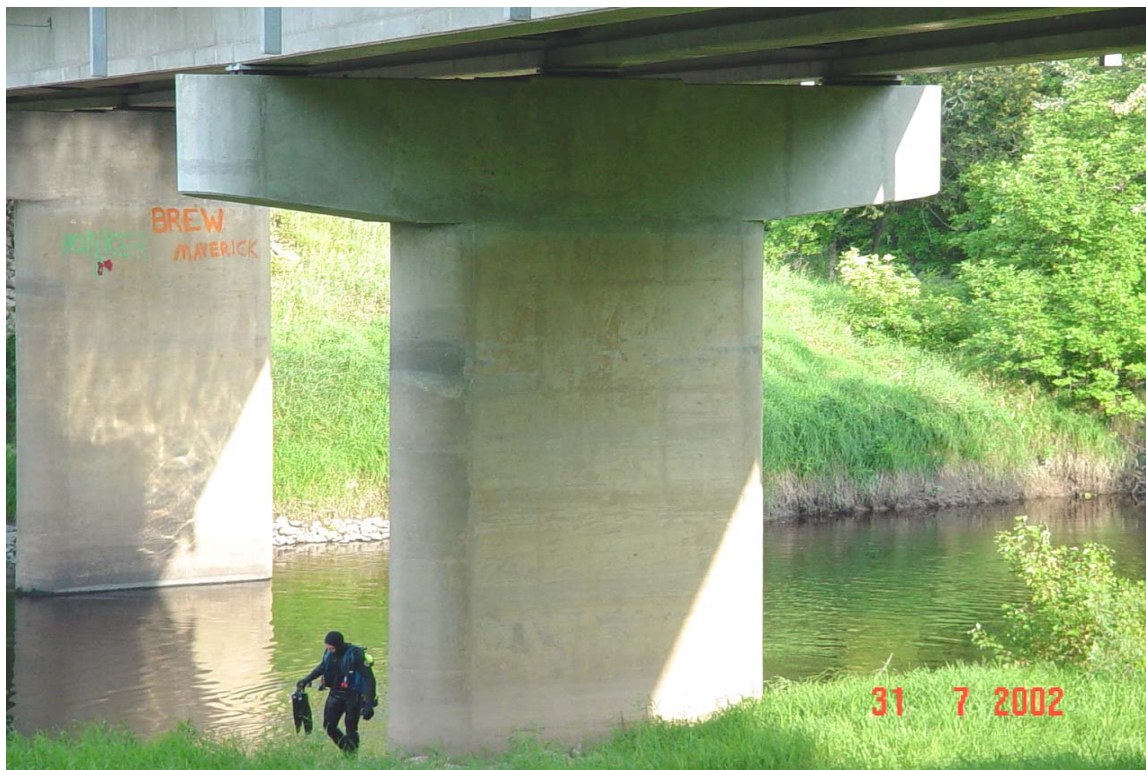
Photograph 3. View of Pier 2, Looking Southeast.

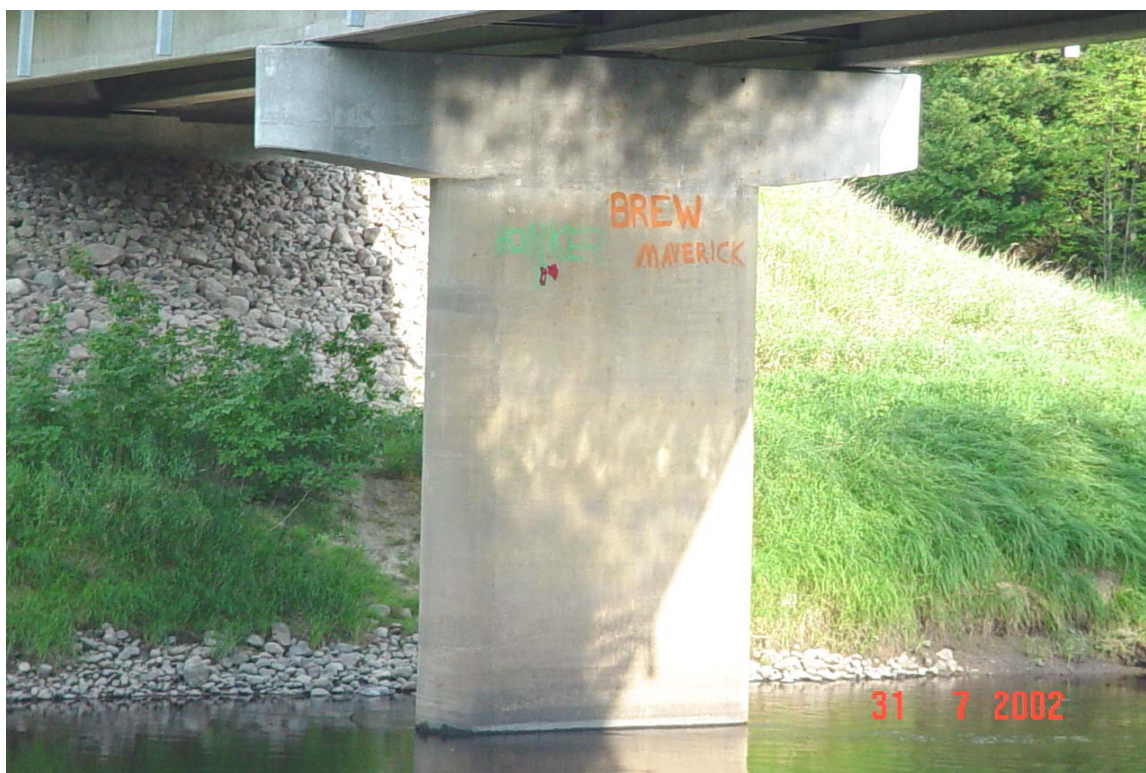
- (A) Light scaling was observed from the waterline to 3 feet above the waterline with typical penetrations of 1/8 inch and a maximum penetration of 1/4 inch.
- (B) A light accumulation of 1-foot-diameter-and-smaller timber debris was observed at the upstream nose of Pier 3. In addition, an 8-inch-diameter log was observed along the entire length of the east side of the pier.

Photograph 4. View of Pier 3, Looking Southeast.

- (A) Reinspect the submerged substructure units at the normal maximum recommended (NBIS) interval of five (5) years.
